Home Inspection Report

123 Unknown Rd, Somewhere in Wisconsin , WI 53186

Saturday July 31, 2021

Humble Home Inspection LLC
(262) 424-1706
David@HumbleHomeInspection.com

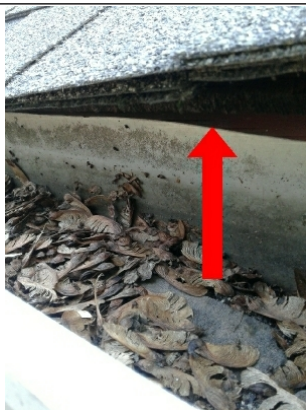
Drip edge flashing was missing on upper roof. No observable issue observed. Recommend monitoring area and add flashing as needed.

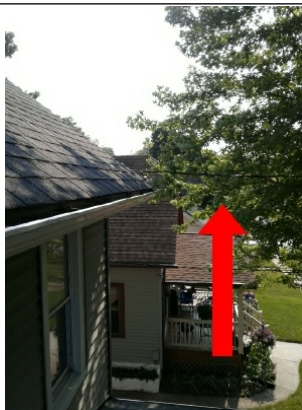
Recommend trimming tree back from the house.

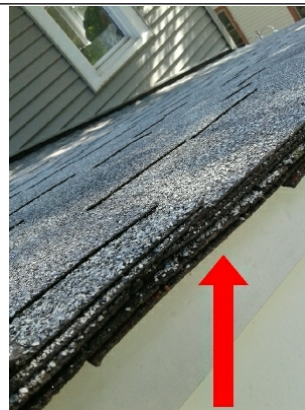
Appeared to be 2 layers of shingles installed. When roof needs to be done again, all the old shingles should come off.

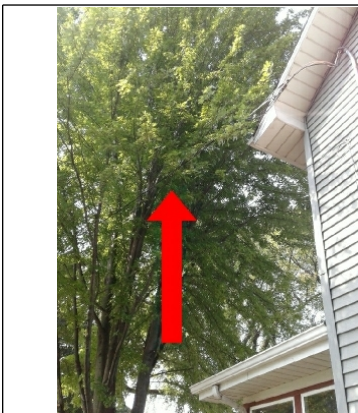
Overhead electrical wires were running through the tree, recommend trimming branches away from the wires.

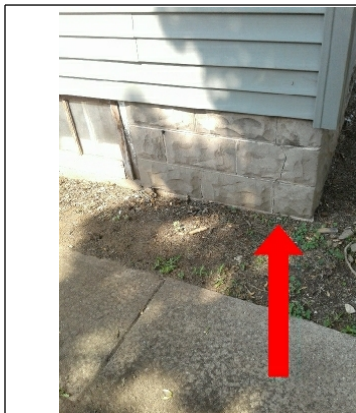
Recommend sealing any cracks in the foundation walls and monitor for any future issue.

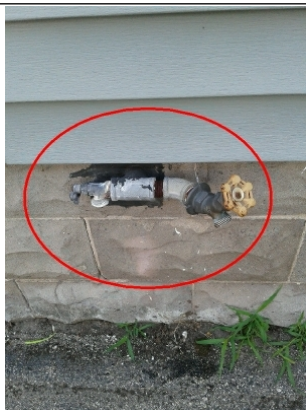
Left hose bib was damaged, recommend repair or replacement. Water may not be turned on from inside valve.

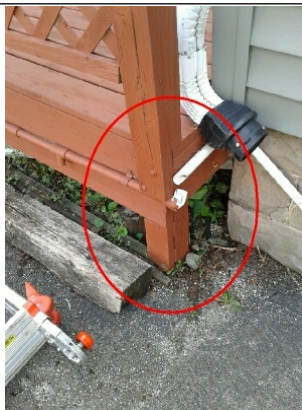
Piping for hose bib was broken. Recommend repair or replacement. Recommend not using PVC pipe. Water sitting in pipe will freeze and burst pipe. All hoses and piping need to be drained in winter and shutoff valves closed to help prevent frozen pipes.

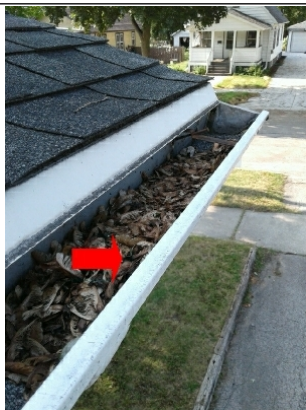
Recommend cleaning gutters.

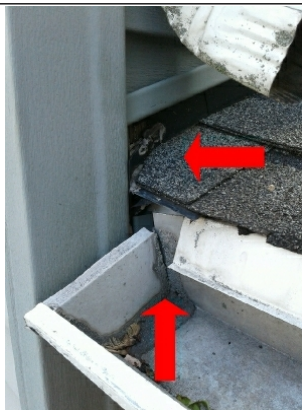
Gutter was coming undone, recommend securing gutters properly. Gutters are probably leaking in some areas, recommend repair as needed. Left arrow - kick out flashing was installed but there was some area of exposed wood behind it. Recommend sealing or reflashng area to prevent water intrusion.

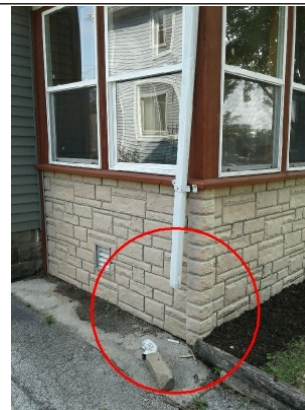
Recommend all downspouts be properly attached and extensions added to divert water from the house.

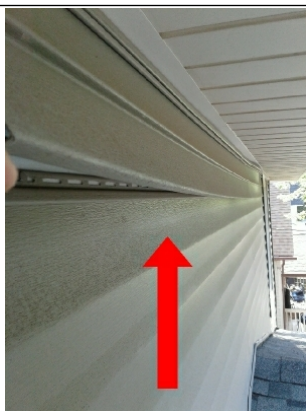
Some areas of siding needed securing.

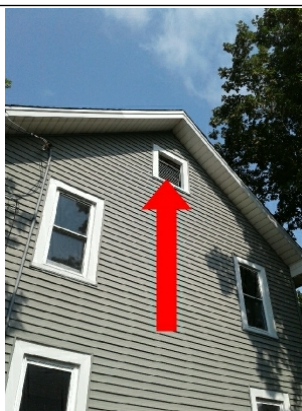
Gable vent was loose, recommend repair or replacement.

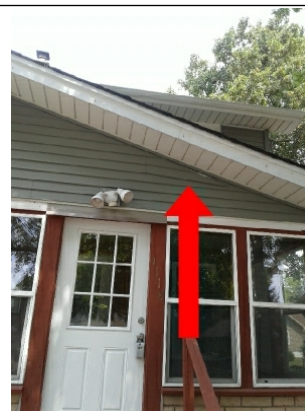
Another area of loose siding, recommend repair or replacement.

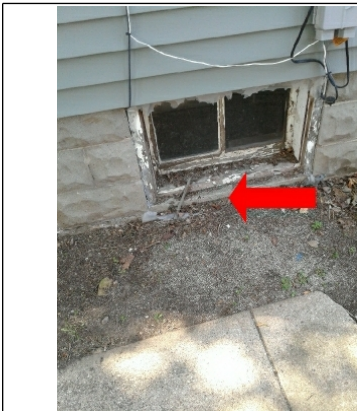
Basement windows appeared to be original and had some deterioration, repair or replace as needed.

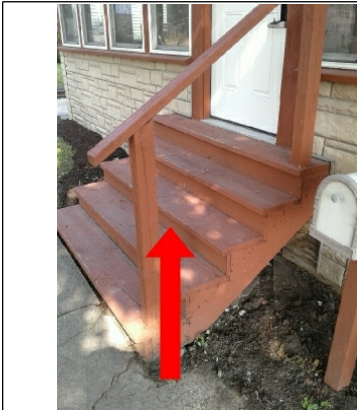
Handrail was loose, recommend securing. Also, ballusters could be installed for enhanced safety. With the steps being wider than normal a second handrail could be installed on the other side for enhanced safety.

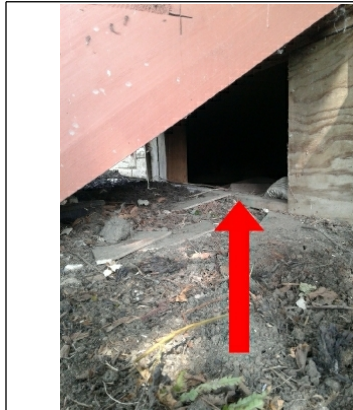
Small access to underside of porch. Recommend blocking area off to keep people, pets or pests out of area.

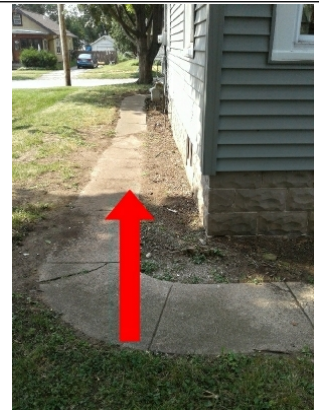
Service walk had settled towards the house. Negative grade present. Recommend sloping walkway away from house and adding fill to ensure a positive grade is around the house for proper drainage.

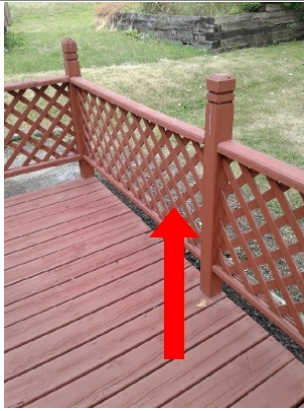
Guardrail was loose, for enhanced safety, recommend securing.

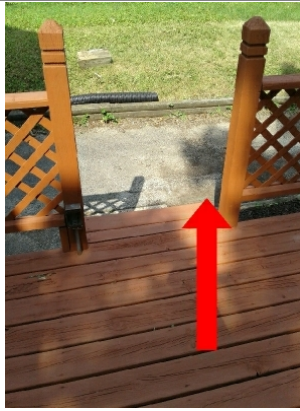
Recommend adding a handrail for enhanced safety.

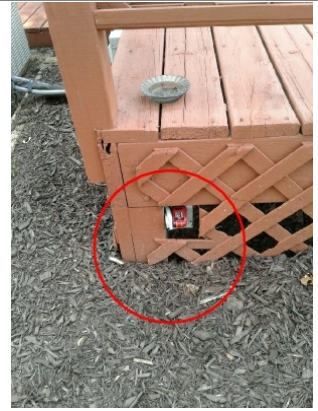
Power on backside of deck was not working, recommend repair or replacement.

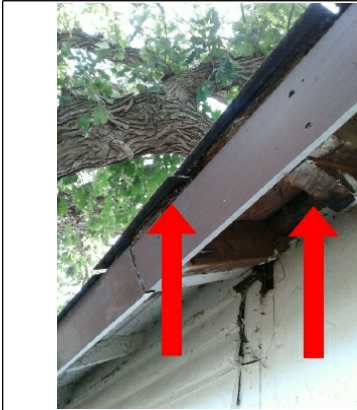
More deterioration observed on soffit and roof.

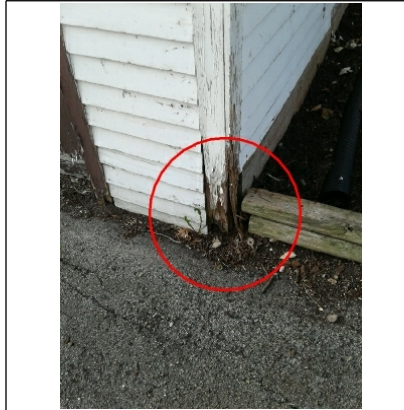
Trim was deteriorated in multiple areas.

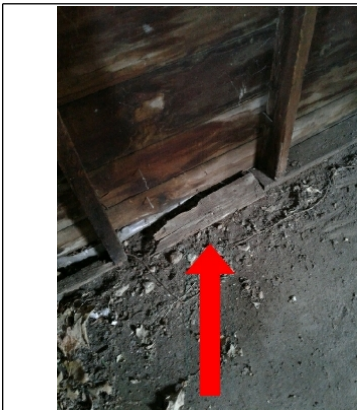
Sill plates were deteriorated in multiple areas.

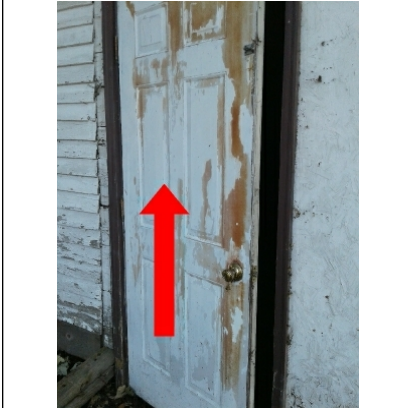
Service Door was deteriorated.

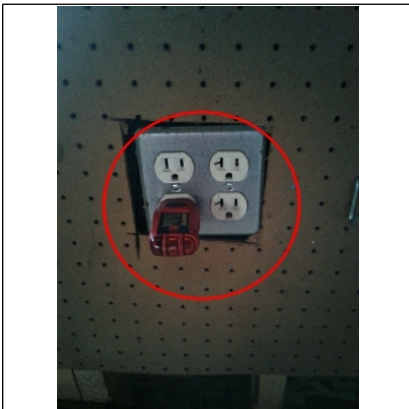
Appeared that there was no power to the garage.

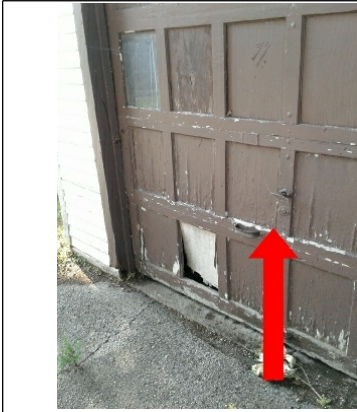
Garage door was deteriorated. It was not tested due to its condition.

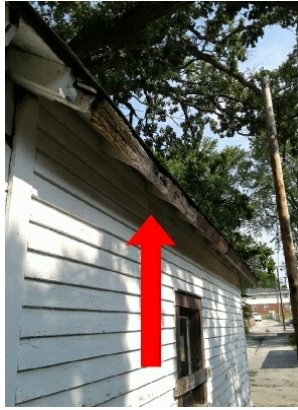
More area of deterioration.

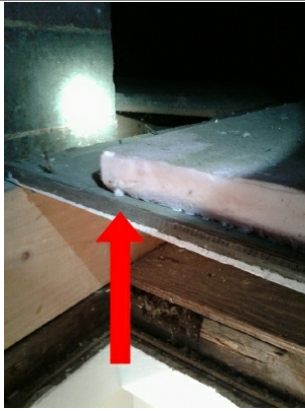
Wood is not a proper firewall material between the living space and the attic. Recommend repair for enhanced safety.

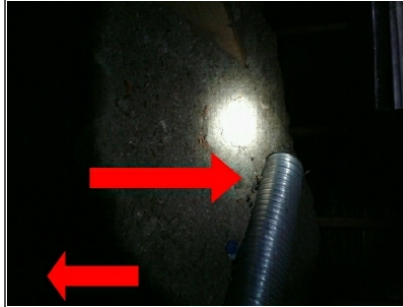
Bathroom exhaust fan was venting into the attic. Recommend that it be vented to the exterior. Insulation was also displaced and compressed in areas, recommend additional insulation to have a smooth consistency throughout the attic.

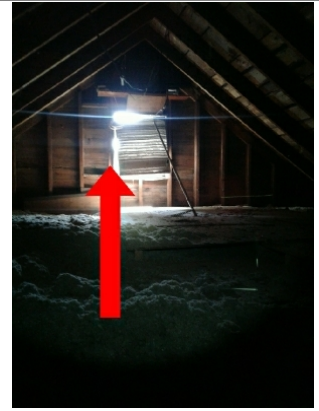
Gable vent was damaged, recommend repair or replacement.

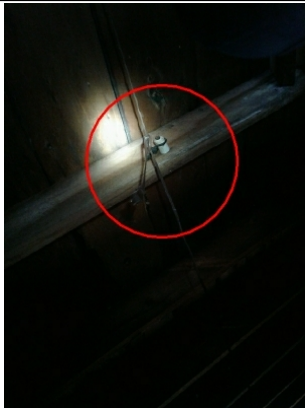
Appeared old knob and tube wiring was abandoned.

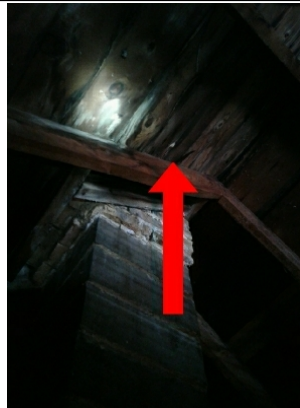
Typical moisture stains observed by the chimney area. No active leaks were observed.

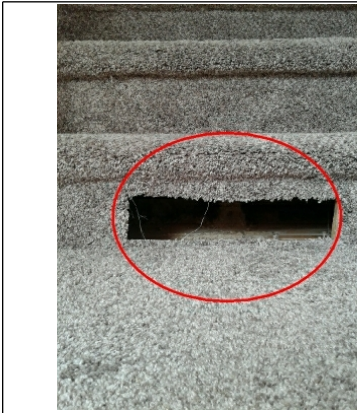
Recommend sealing hole at bottom of the steps.

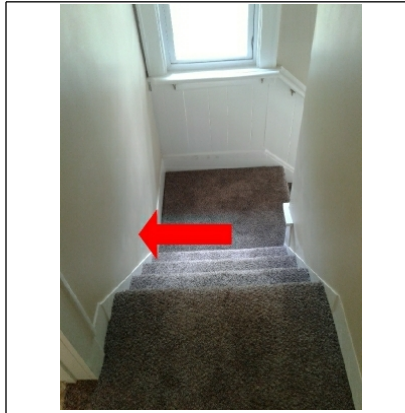
Recommend a proper handrail be added for enhanced safety.

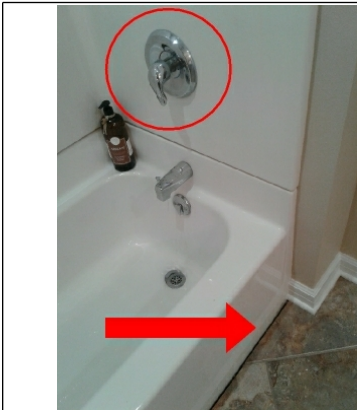
Faucet handle wasn't operating correctly, recommend repair or replacement. Recommend grout and caulking be added at the base of the tub.

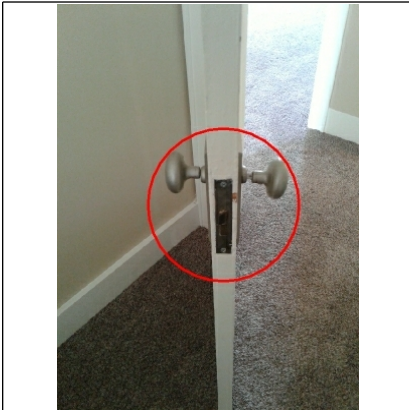
Door handle was loose,
recommend repair or
replacement.

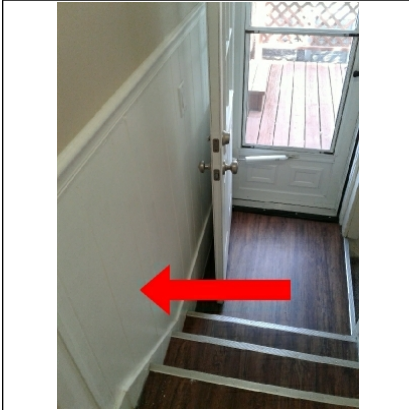
For enhanced safety, recommend a handrail be added.

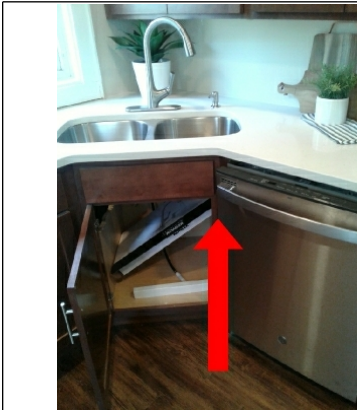
Plumbing for sink and dishwasher weren't hooked up. Recommend that they are properly connected.

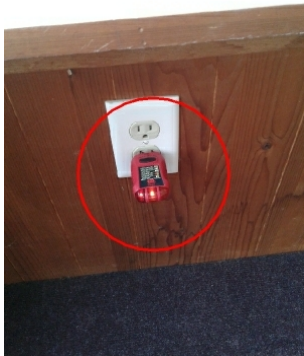
Electrical receptacles in the porch area had reverse polarity. Recommend repair.

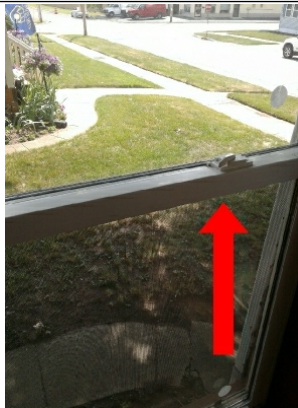
Some windows were difficult to lock and unlock throughout the house. Repair or replace as needed.

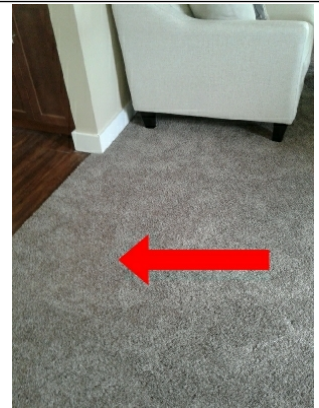
Living room floor had a slight slope to it. Repair as needed.

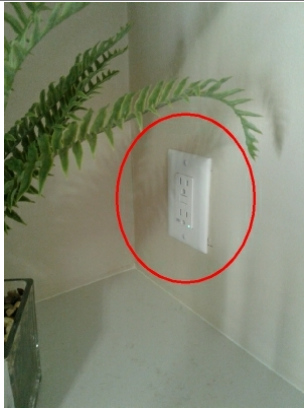
GFCI wasn't operational, recommend repair or replacement.

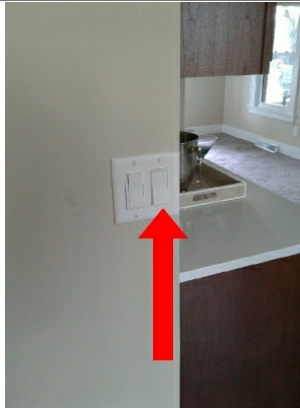
Unsure what the right switch controls.

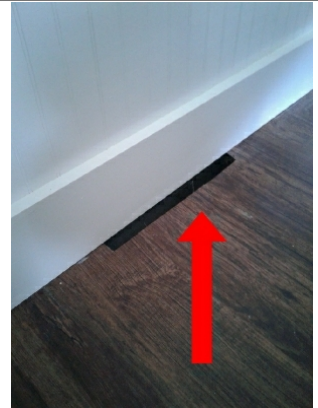
Recommend a vent cover be added.

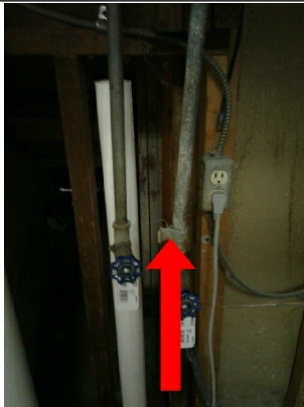
Galvanized water piping present.
No visible corrosion observed.

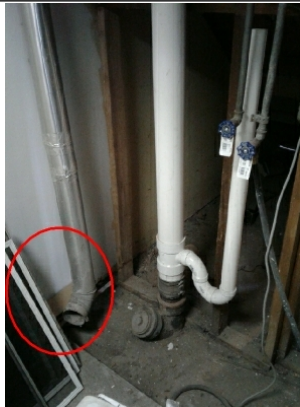
Exhaust for a future dryer,
recommend cleaning dryer vent.

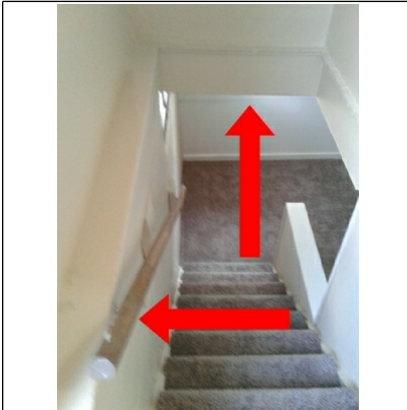
Handrail was loose, recommend repair or replacement. Items can catch on exposed end, recommend a handrail that returns to the wall. Low clearance above stairway, use with caution.

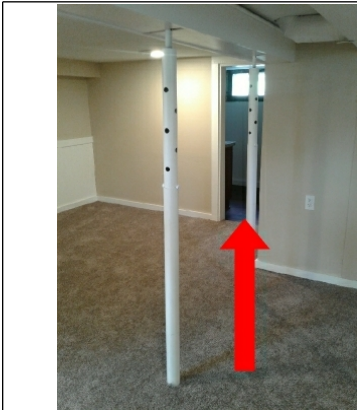
Appeared columns had been added for extra support. No observable issue noted at the time of the inspection.

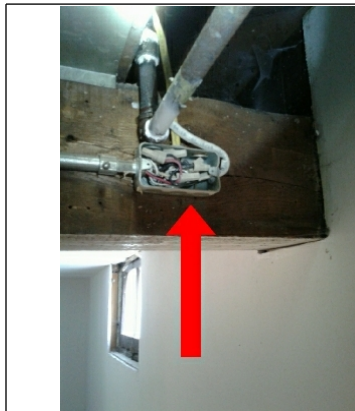
Recommend a cover plate be added.

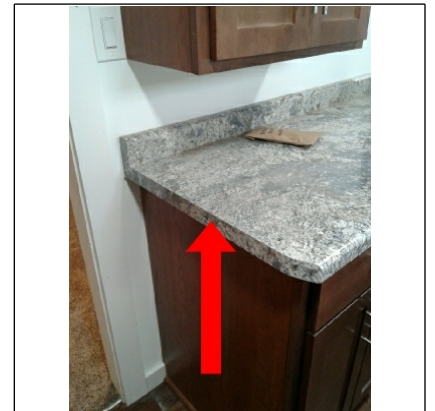
Countertop was not secured, recommend securing.

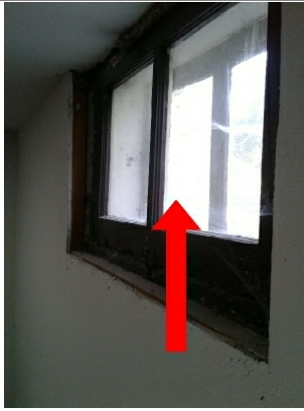
Basement well windows had some deterioration, repair or replace as needed.

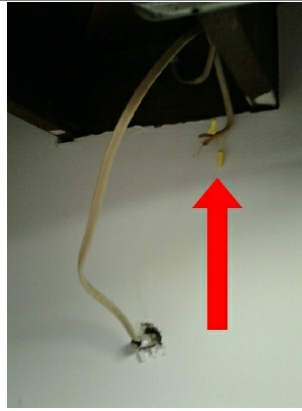
Loose electrical wiring may be live, potential safety hazard. Recommend wiring be properly secured in a junction box.

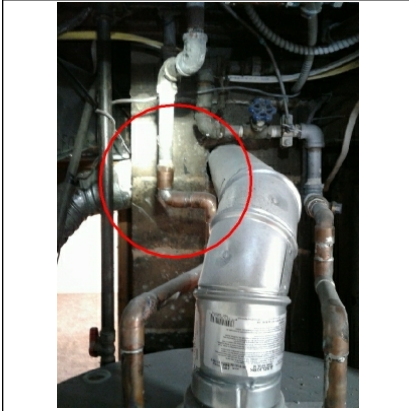
Where copper and galvanized piping meets there is the potential for corrosion. Recommend monitoring those areas, and add a dielectric union if needed.

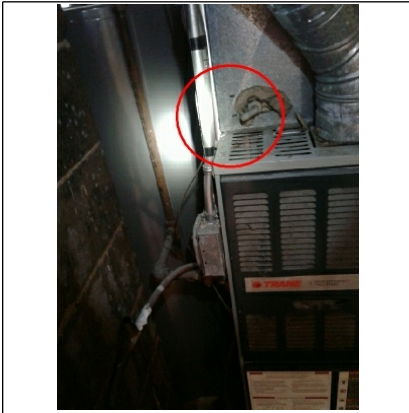
Hose for air handler condensate had come off, recommend reattaching. AC hasn't run in a while due to lack of moisture that would be in this area.

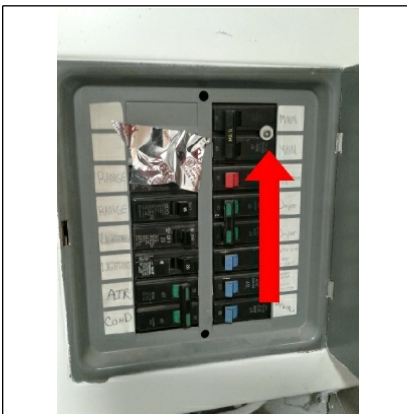
Electrical panel wasn't able to be safely accessed due to a screw being improperly screwed into the panel. Recommend a qualified contractor evaluate further.

Improper screw was dangerously inserted into the main breaker. Cover was not removed due to the potential safety concern. Recommend a qualified contractor evaluate further.
