Home Inspection Report

123 Unknown Rd, Somewhere in Wisconsin , WI 53186

Saturday July 31, 2021

Humble Home Inspection LLC
(262) 424-1706
David@HumbleHomeInspection.com

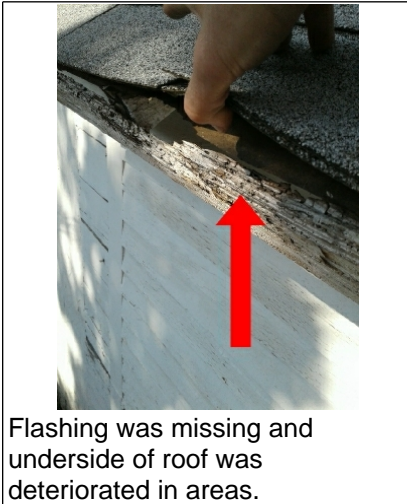
Garage/Carport

Garage had multiple issues, it is in need of repair or replacement. Recommend not using in its current state. See garage section for details.

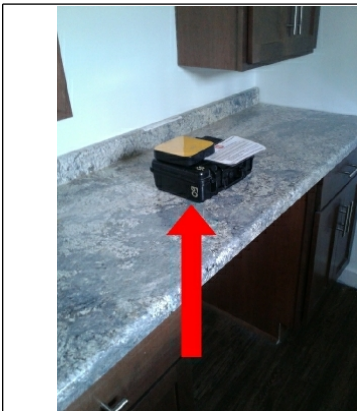
Radon monitor was set.
